Lessons Learned from The Great East Japan Earthquake and Tsunami ~ Restoration and Reconstruction of Power Facilities ~

Research & Development Center, TOHOKU EPCO.

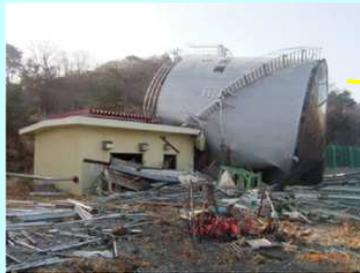
A heavy oil tank for unit 1.
(Collapsed)

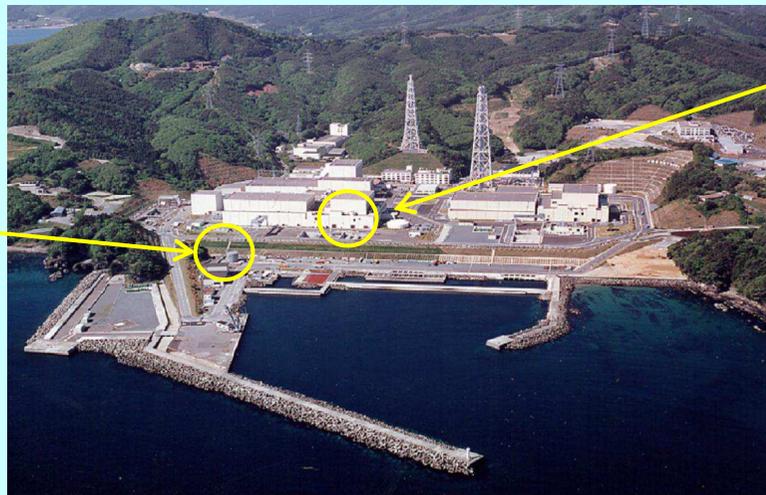
Accessory of reactor building for unit 2. (Sea water flooding.)

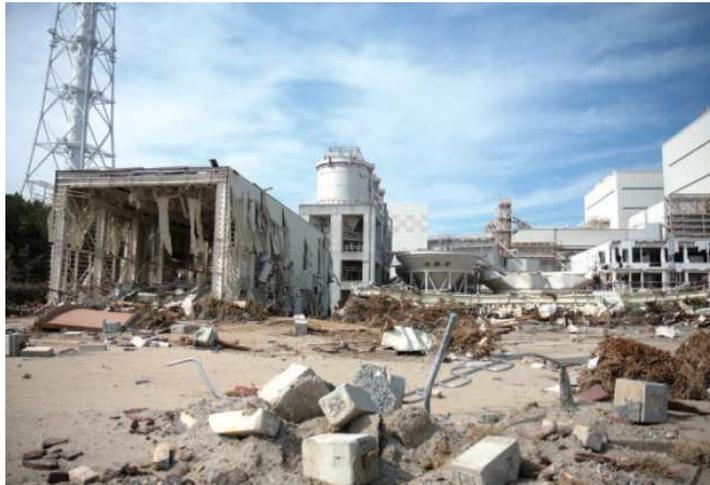
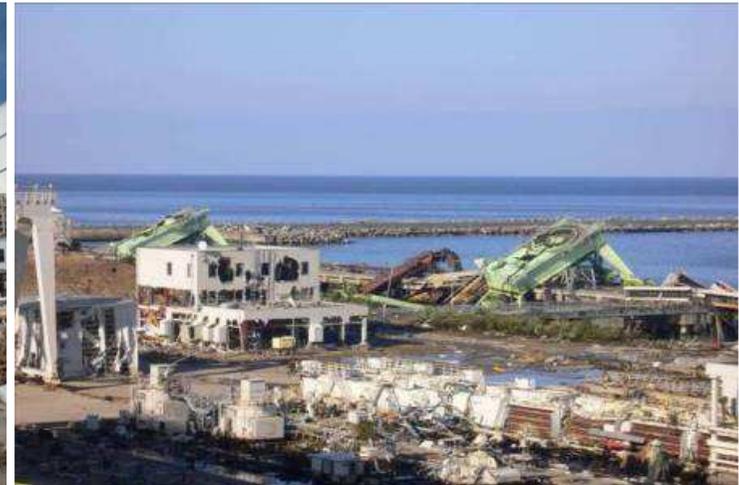
Haramachi Thermal Power Station with a capacity of 2,000 MW was devastatingly damaged by the **about 18m-height tsunami**.

Thanks to the strenuous reconstruction effort on 24-hour basis, **it resumed full operation in April 2013**, which greatly improved the stability of power supply in the Tohoku region.
As the damage was quite severe, it took as long as two years to resume the full operation.

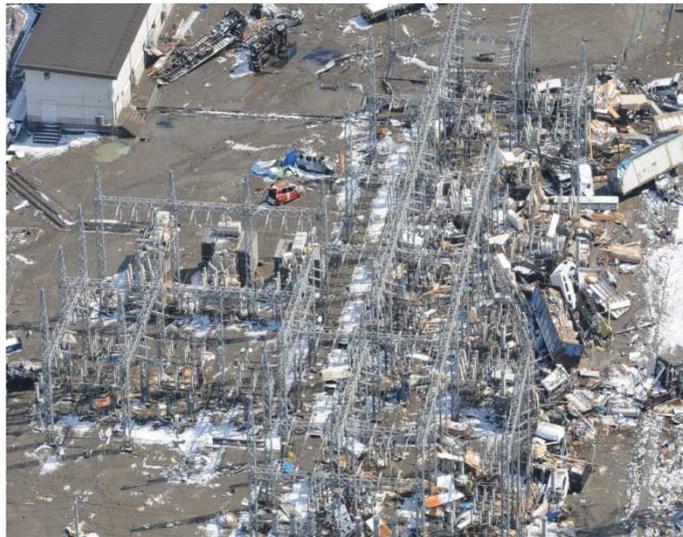
A great amount of debris destroyed substation structures and apparatuses.

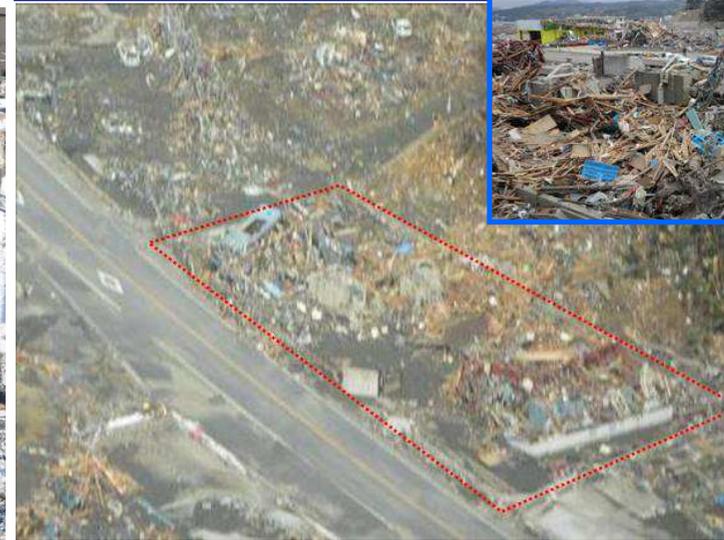
Some substations were submerged and some were nearly swept away by the tsunami.

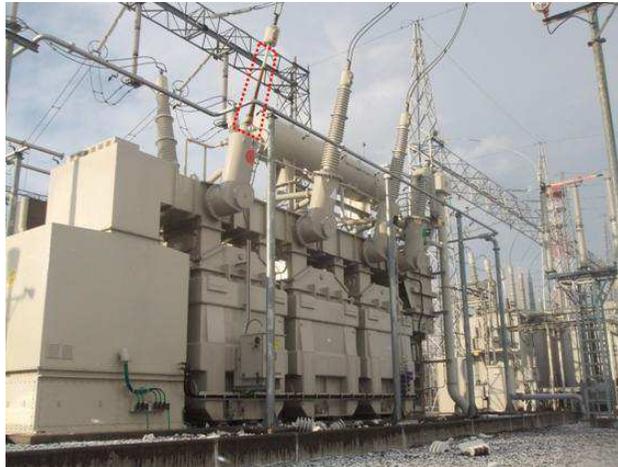
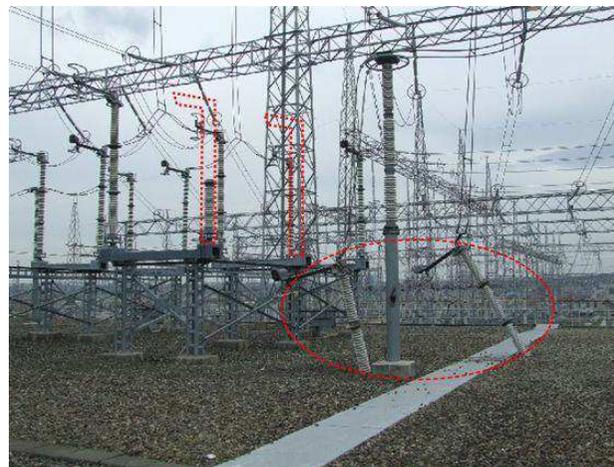
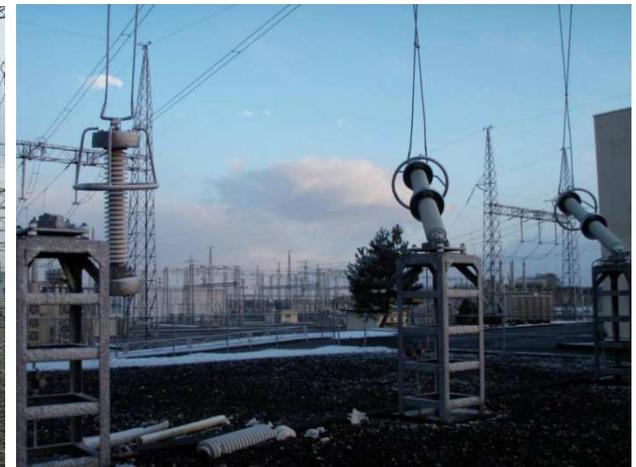
A number of substation apparatuses such as transformers, disconnectors, and lightning arresters were broken by vibration.

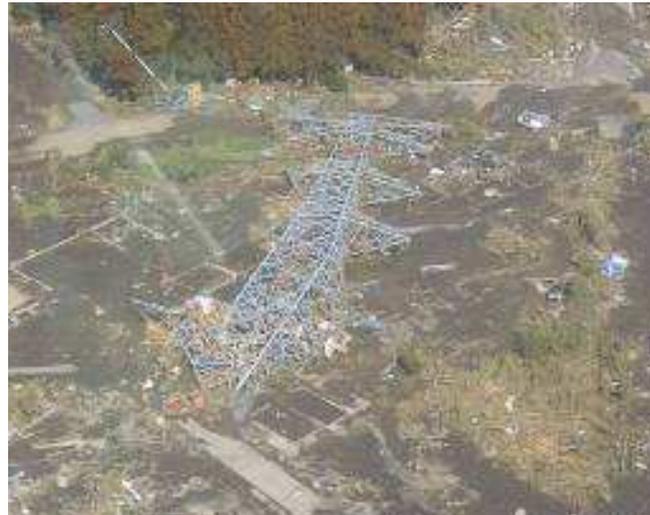
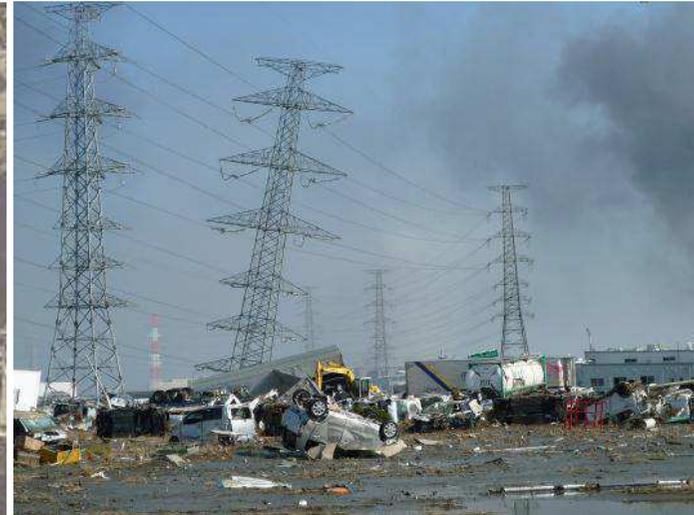
Transmission towers were collapsed or tilted by massive debris, such as wave-dissipating concrete blocks and broken rails of railway, attacking them.

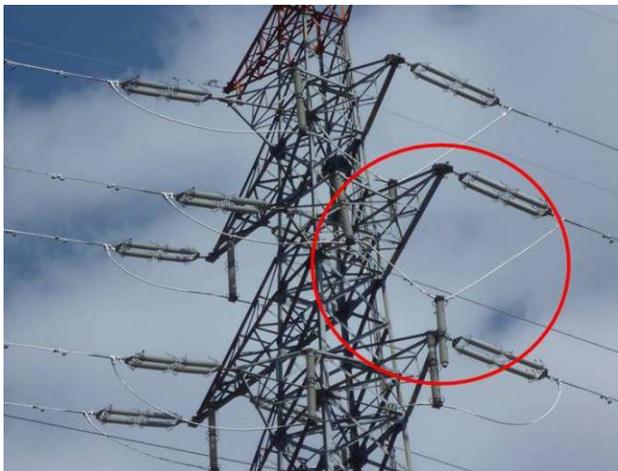
Jumper support long-rod insulators were broken by massive vibration.

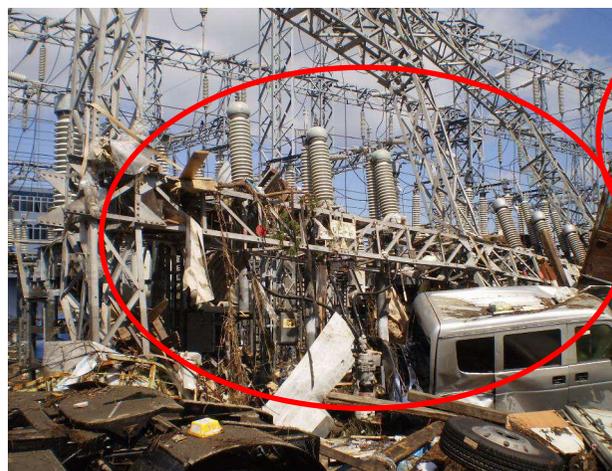
Cable accessories, such as terminations and oil-filled tanks, were destroyed by the debris of the tsunami.

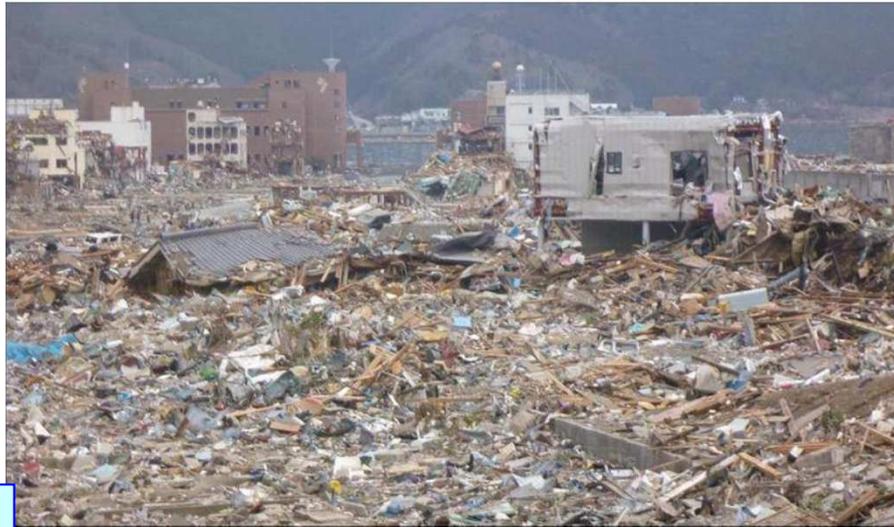
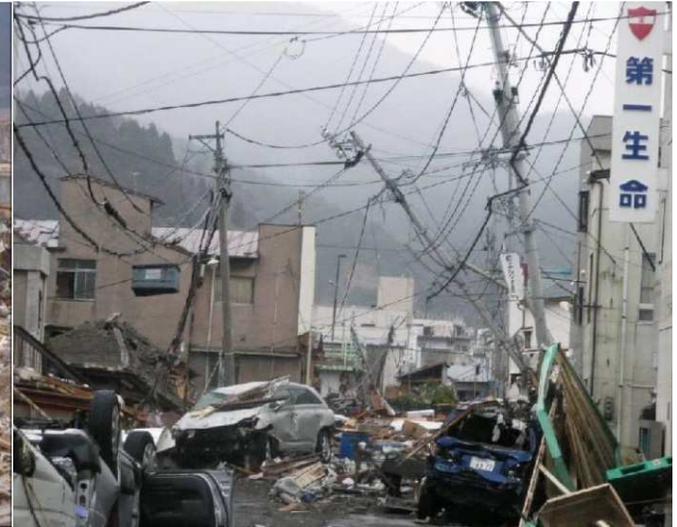
Some areas were nearly swept away and no poles and wires could be seen.

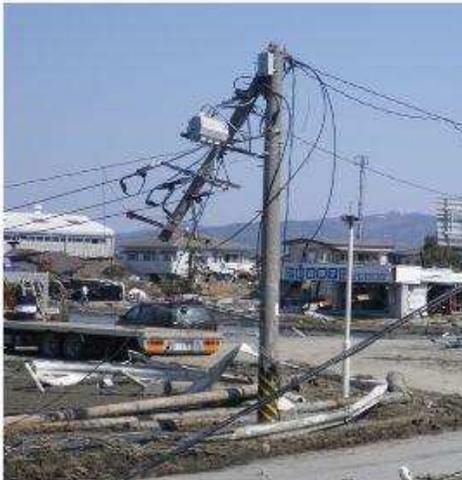
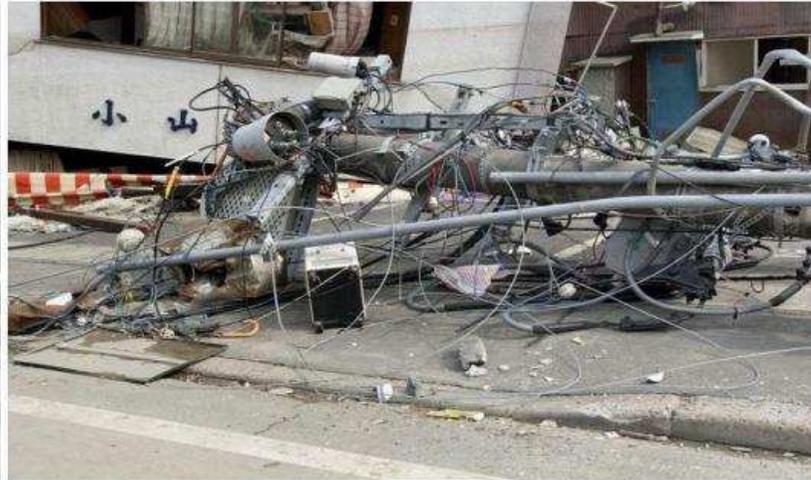
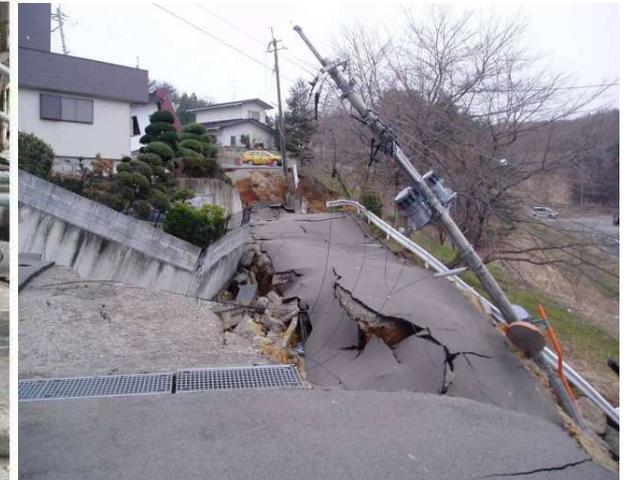
A great number of poles, wires, and accessories such as pole transformers were collapsed or broken.
