Lessons Learned from The Great East Japan Earthquake and Tsunami ~ Restoration and Reconstruction of Power Facilities ~

Research & Development Center, TOHOKU EPCO.

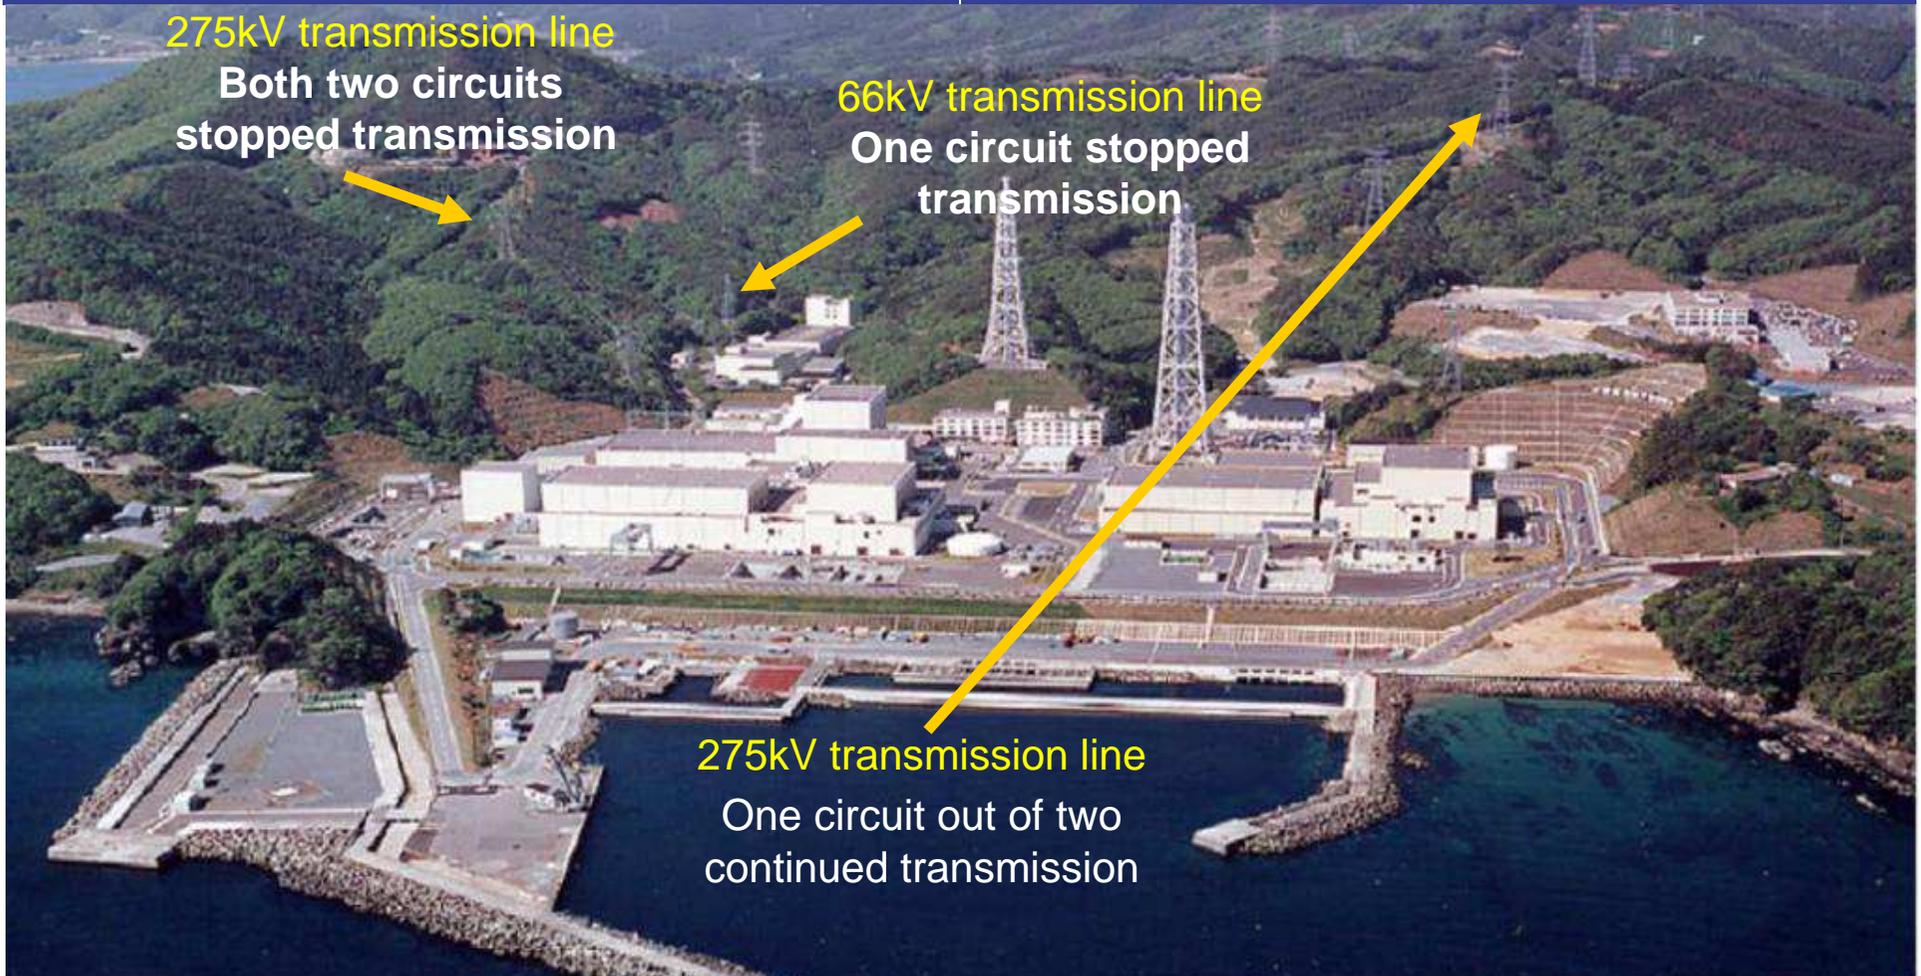
Damages of Facilities ~ Onagawa Nuclear Power Station ~

**One out of 5 transmission line circuits continued power transmission.
Six out of 8 emergency diesel generators were integral.**

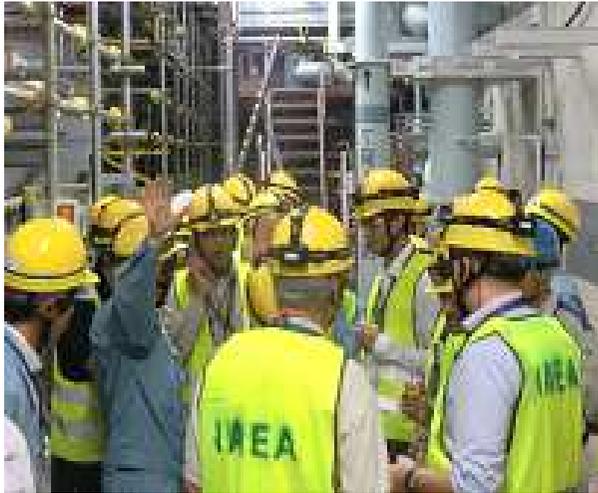
Damages of Facilities ~ Onagawa Nuclear Power Station ~

IAEA Expert Team investigated the Onagawa NPS in summer 2012, and published a report.

“It was concluded that the facilities of the Onagawa NPS remain “remarkably undamaged” given the magnitude, distance and duration of ground shaking.”
